Accident Bulletin 2/2012
(An update to Accident Bulletin 3/2011)

Aircraft type:	Aerospatiale SA 315B LAMA helicopter
Registration:	B-HJV
Year of manufacture:	1972
Number and type of engines:	One Turbomeca Artouste IIIB turboshaft engine
Date and time of accident:	3 January 2011 at around 0556 hrs UTC (1356 local time) Note : Hong Kong local time is UTC time + 8 hours
Place of accident:	Kau Lung Hang Lo Wai, Fanling, New Territories, Hong Kong
Nature of Accident:	<p>The helicopter was conducting an underslung load operation on the hillside of Kau Lung Hang Lo Wai, Fanling. When the helicopter was setting down a load onto a work site located near an overhead high voltage electricity line pole, a sudden flash of fire occurred adjacent to the power cables below the helicopter. The generated sparks and smoke cascaded onto the ground, causing injuries to two ground workers.</p> <p>After the accident, the helicopter climbed out of the site and returned to its base in Sek Kong. The underslung assembly and several items of the aircraft equipment were found to have been damaged.</p>

**Update on Investigation of Helicopter Accident involving
the Aerospatiale SA 315B LAMA (Registration Mark

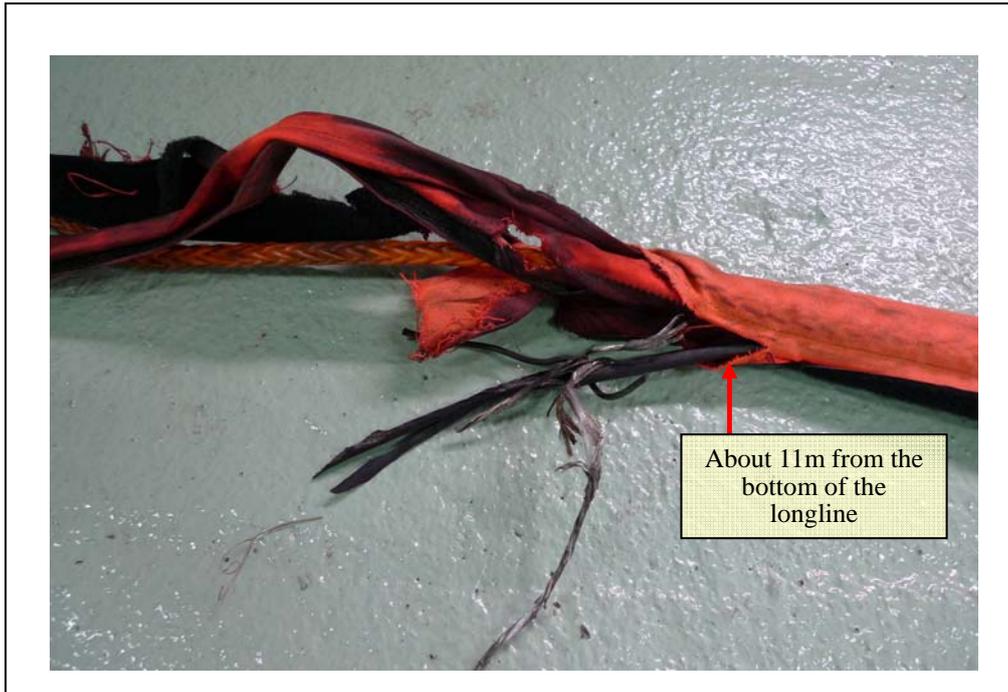
3. The lower 11 metres of the 100-foot (30.5 metres) longline’s protective nylon jacket was found to have been crisped and fragmented with a large portion of the shrouded electrical cable missing (see Figure 1). The remote-controlled hook which was connected to the bottom end of the longline was charred, showing clear burn marks and signs of flashover (see Figure 2). The length of this damaged section of the longline was consistent with the height of the overhead lines at Pole 9 of the “Fanling – Ting Kok Road No. 1 132 Kilovolts Overhead Line Circuit (“FNL-TKR No. 1 Circuit”)” (See Figure 3).

Figure 1 : The lower 11 metres of the longline’s protective nylon jacket was found to have been crisped and fragmented with a large portion of the shrouded electrical cable missing.

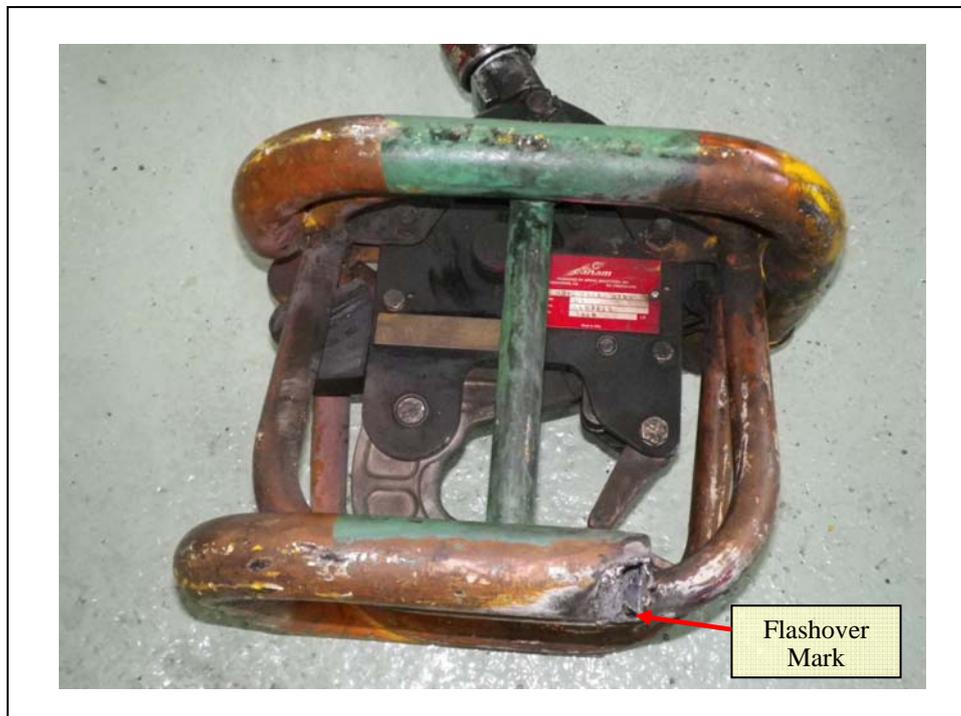
Figure 2 : The remote-controlled hook which was connected to the bottom end of the longline was charred, showing clear burn marks and signs of flashover.

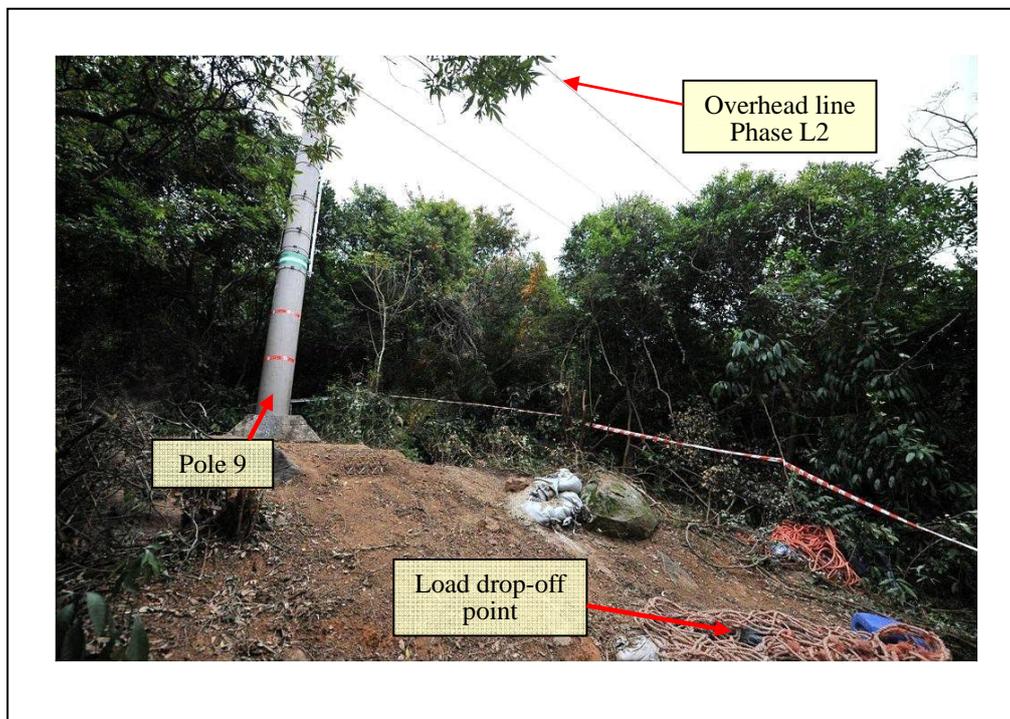
Figure 4 : The relative location of Pole 9 of the “FNL-TKR No. 1 Circuit” and the accident work site

5. At Pole 9, there were three live overhead lines located on the two sides of the supporting pole, namely Phase L1, Phase L2 and Phase L3, with Phase L2 located at the side on which the underslung load operation was conducted (see Figure 4). The event log of China Light and Power Limited (“CLP”) showed that within a short duration of approximately 168 milliseconds between 0556 and 0557 hrs (between 1356 and 1357 local time), there were substantial disturbances in the voltage and current waveforms of Phase L2. This indicated that a short circuit had occurred in Phase L2 of the FNL-TKR No. 1 Circuit. Phases L1 and L3 only showed minor consequential disturbance due to the short circuit in Phase L2, indicating that there was no short circuit in these phases.
