**AIRCRAFT ACCIDENT REPORT 1/2015**

**Report on the accident to Robinson R22 Beta II Helicopter  
Registration B-HJN operated by the  
Hong Kong Aviation Club Limited  
at Shek Kong Airfield, Yuen Long  
on 6 October 2013**

**Hong Kong  
February 2015**

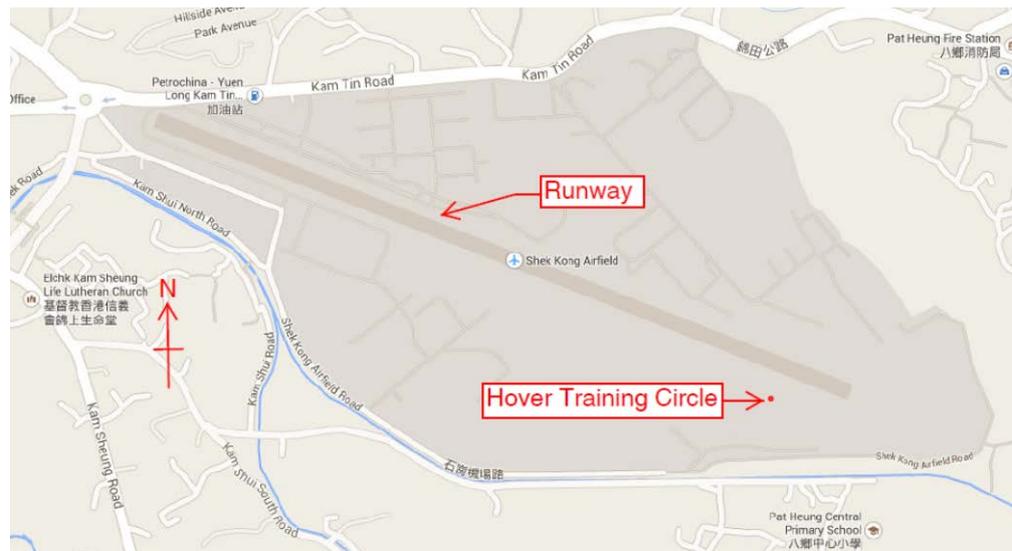
Figure 1 – The Hover Training Circle in Shek Kong Airfield

1.1.2 On that day, the Instructor was assigned with five training flights scheduled between 08:30 and 18:00. The accident happened on the fourth flight, which was a training flight on hover exercise. The hover exercise was conducted within SK, at the hover training circle located south of the runway. (See Figure 1)

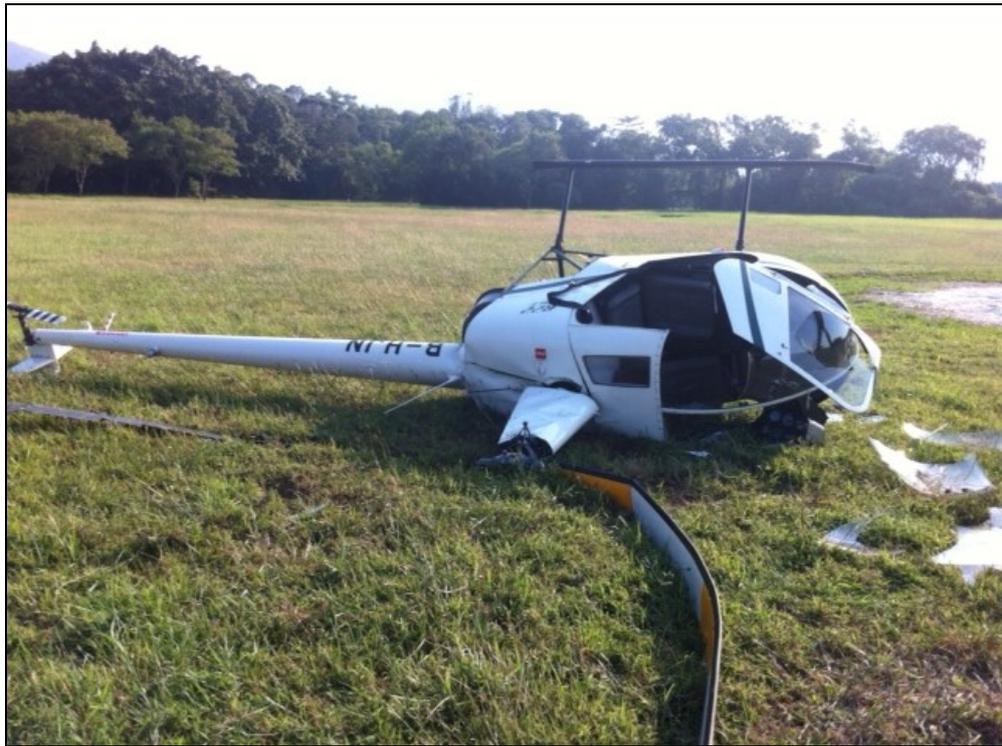
Photograph 1 – The Wreckage

1.1.5 The Instructor described that he did notice the helicopter was drifting to the right. In a second, the drift developed rapidly into a descent and a roll. The Instructor attempted to reach for the controls but was not able to touch the controls in time. The right skid contacted the ground. The helicopter rolled over 90° to the right, hit the ground and came to rest on its side (See Photograph 1). The engine stopped on impact.

Severe damage to the perspex canopy, horizontal stabiliser, main rotor blades, and deformation to the horizontal firewall were evident. The right skid tube extension was bent slightly inward. The damage was consistent with the impact upon the helicopter rolled over.

2.1.1.4 The post-accident inspection noted an inward bend to the right skid tube extension of the helicopter. It indicated that the helicopter had the right skid tube extension contacted the ground during its rightward drift before the helicopter rolled over.

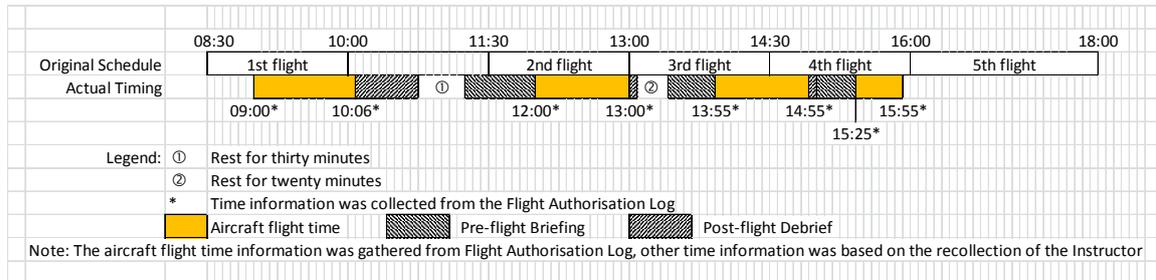
Figure 2 – Flying Training Arrangement and Execution of the Instructor

1.14.2.2 On the day of the accident, there were 12 helicopter training flights to be shared among three instructors. The Instructor and another flying instructor (“ ‘Instructor A’ ”) were each assigned five training flights starting at 08:30. The Instructor was assigned one flight between 08:30 and 10:00, and four flights between 11:30 and 18:00 (See Figure 2).

- 2.1.3.3 The back-to-back arrangement of the booking slots, in the context of flying training arrangement, provided little allowance for flying instructors to take rest between flights. Inevitably, pressure on flying instructors to work continuously would be high in particular when there was a need to catch up with the schedule.

- 2.1.3.4 Taking into account the high training demand, the practice of assigning flying instructors without due consideration to their workload and rest periods was conducive to the development of tiredness.

- (a) A maximum of four instructional flights be conducted by an instructor per day.
- (b) Instructors might not conduct more than two consecutive instructional flights without rest.
- (c) Consideration on separating “high stress” flights in flight programming.
