**Report of the Incident Review Panel
on the Train Fire inside
West Rail Tai Lam Tunnel
on 14 February 2007**

April 2007

Kowloon-Canton Railway Corporation

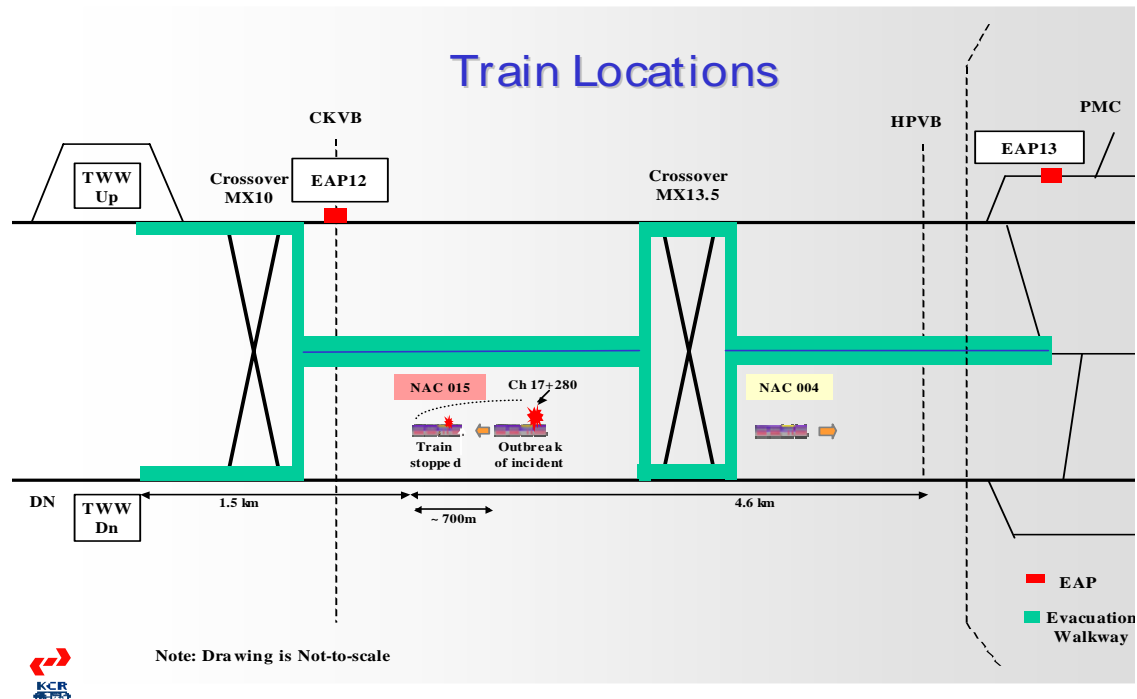
The train came to halt at a position about 100 m from the mid tunnel crossover MX13.5. The train driver closed the dampers in view of smoke coming from the front to prevent the ingress of smoke into the train saloon. A sketch of the locations of trains inside TLT at the time of the incident is shown below -
