# **In-flight Breakup**

## **Safety Investigation Preliminary Report**

**Robinson R44 II**

**B-KTK**

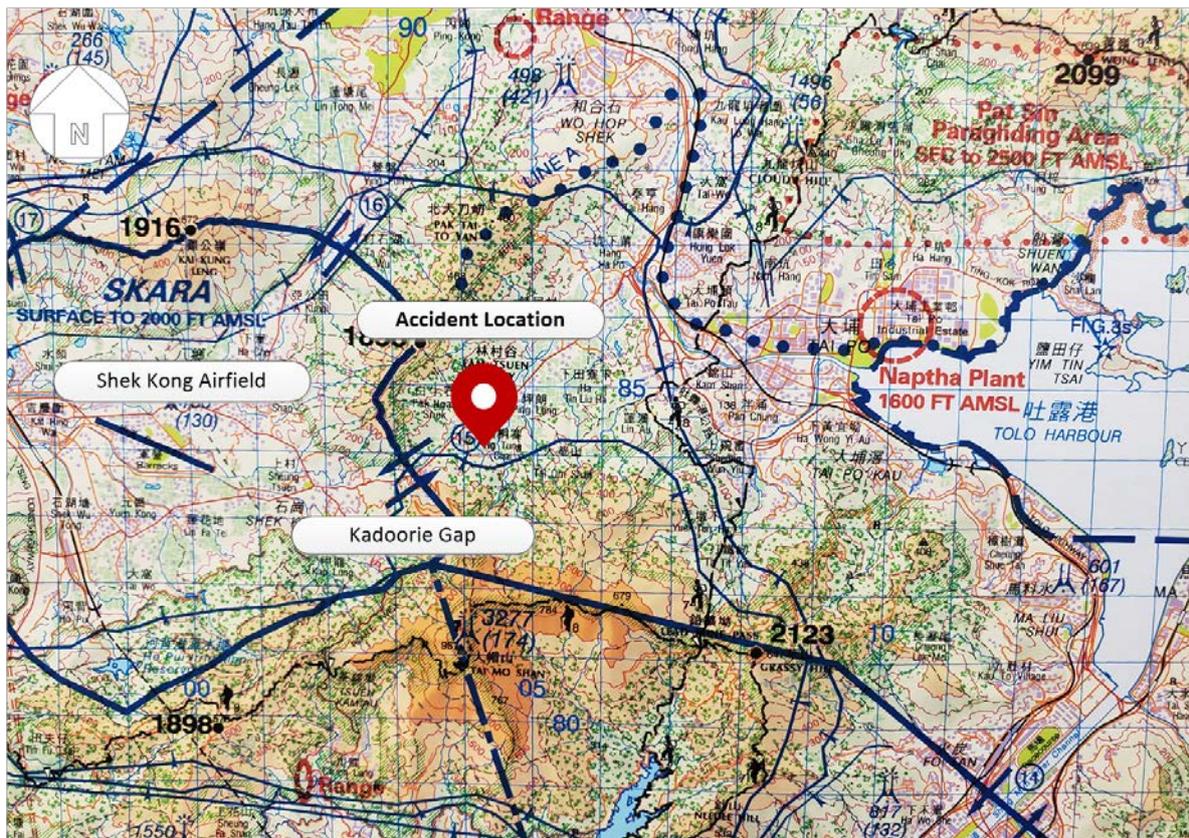
Figure 1: Accident Location

The debris trail of the helicopter following the in-flight breakup was scattered in a south-westerly direction for approximately 500 meters. The debris trail begins near Lam Kam road and finishes at the fuselage impact point.
